Case Study: Head Stud Removal

ASAP Power was engaged by a customer to erode 3x snapped head-bolts on a FIAT bulldozer. Failure to cleanly remove the 3x snapped studs would have left the engine as scrap.

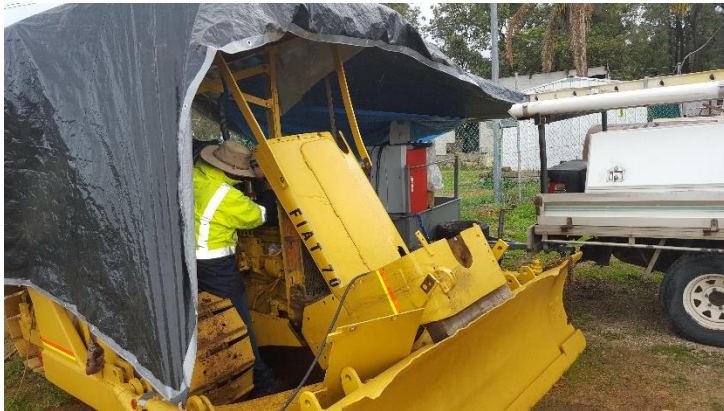
The studs were snapped at the bottom of the coolant jacket, 270mm deep.

Our experienced spark erosion team set up a bracket that was mounted on the side of the cylinder block, fitted a cross table to allow for accurate X/Y positioning. Our special made magnetic stand allowed feed in the Z axis.

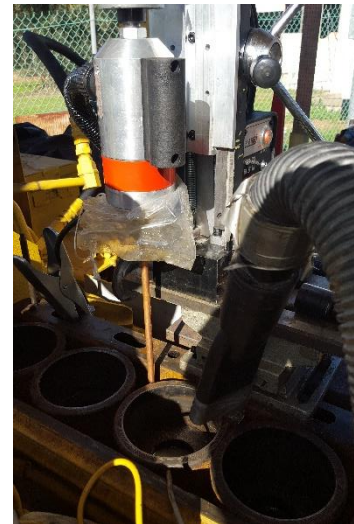
Head studs

Snapped stud

Eroded hole

Extracted stud

A custom made 10mm electrode eroded the core of the M18 stud, relieving tension in the stud. The remaining spike was then eroded using 6mm electrode which provided the necessary clearance to use an "EasyOut" style extractor to remove the remains of the thread.
