## Case Study: Spark Eroding snapped drill out of Aluminium Profile

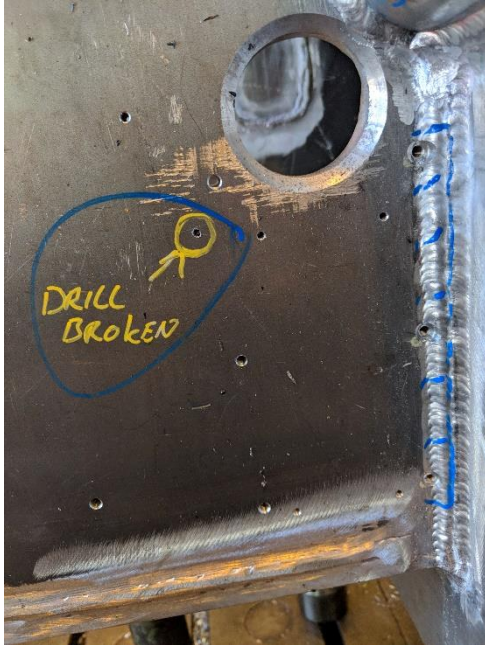
A customer approached us to remove a snapped 3.3mm High Speed Steel drill bit out of an aluminium workpiece. Due to the size and urgent nature, the customer did not want to move the workpiece from its current operation on a horizontal machining centre, as such ASAP Power had to deploy our mobile spark eroding solution to site.

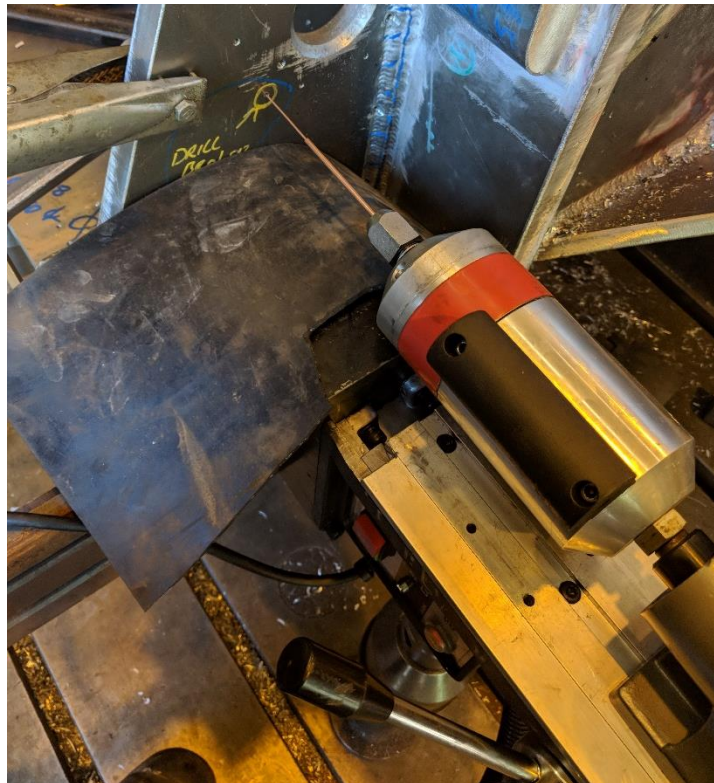
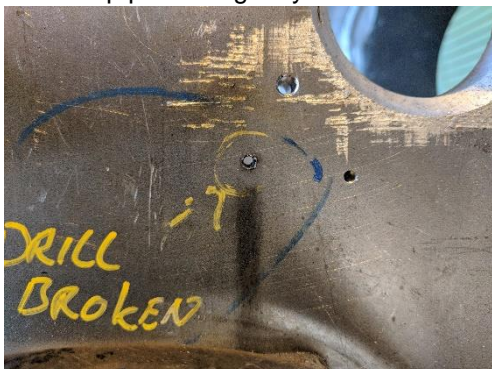
ASAP Power staff used a customized set-up for the non-ferrous job consisting of a XY cross table bolted onto the workpiece and a modified magnetic base used to guide a custom made electrode into the workpiece.

The electrode required customization as for a 3.3mm drill a 1.5mm round hollow copper electrode was required. However, due to the horizontal orientation this was subject to high oscillations and electrode sagging. To compensate for this we used a 3.0mm electrode with a 1.5mm tip protruding only 50mm.

The end result? The drill was removed successfully with no damage to the workpiece.
